Subject: Duke Power Company LLC d/b/a Duke Energy Carolinas, LLC
(Duke)
Catawba Nuclear Station, Units 1 and 2
Docket Nos. 50-413 and 50-414
Licensee Event Report 413/06-001

Attached is Licensee Event Report 413/06-001 titled "Loss of Offsite Power Event Resulted in Reactor Trip of Both Catawba Units from 100% Power."

Loss of Offsite Power Event Resulted in Reactor Trip of Both Catawba Units
from 100% Power

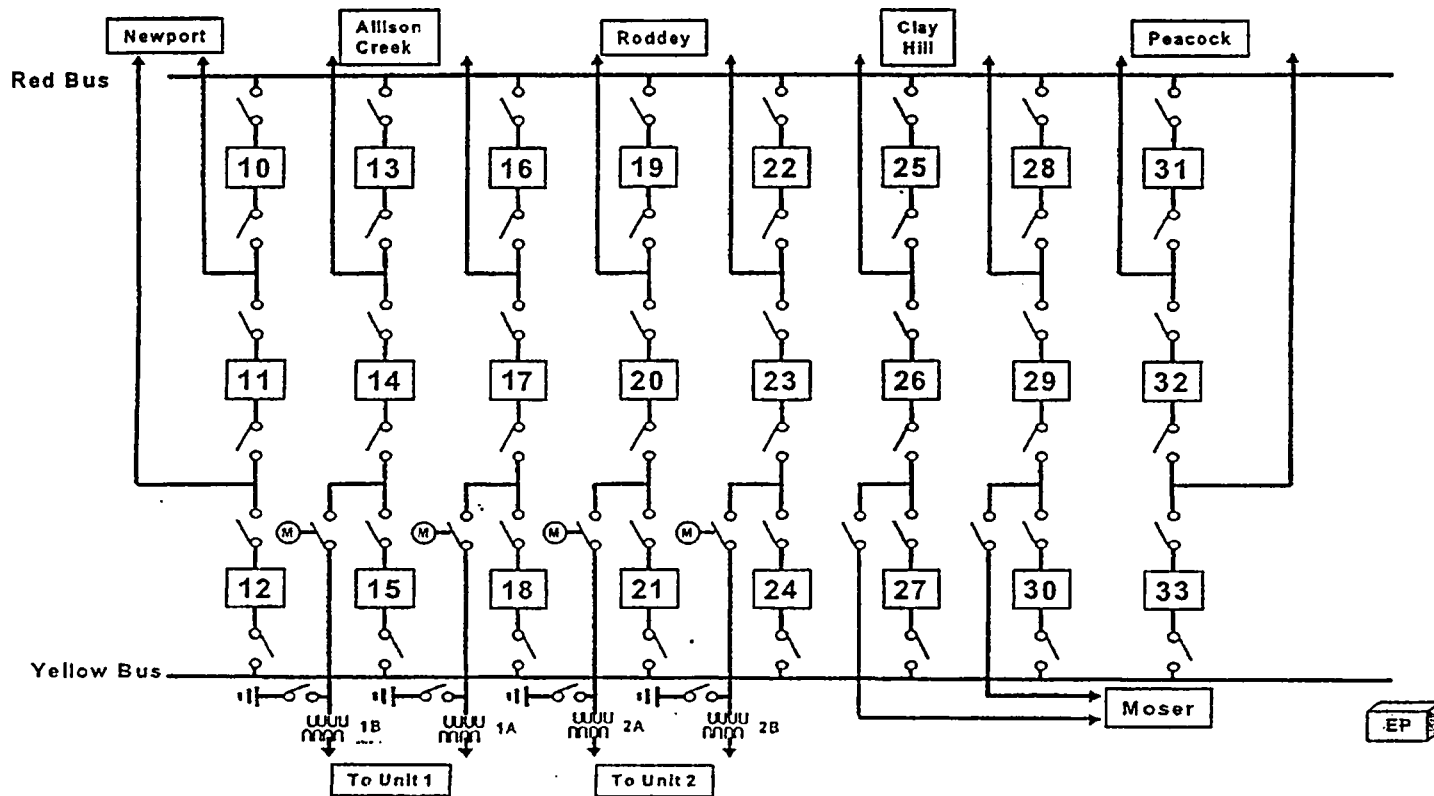
The Catawba 230kV switchyard [EIIS: FK] is designed in a breaker-and-a-half scheme which allows any one of the switchyard power circuit breakers (PCB) [EIIS: 52] to be isolated from the grid without deenergizing any transmission line or affecting the integrity of the switchyard. Six double-circuit transmission lines from the primary transmission system terminate in the switchyard. Additionally, each Catawba unit is tied to the 230kV switchyard by two separate and independent overhead lines. The entire switchyard, including the power circuit breakers, cabling system, ac and dc auxiliary power systems, protective relaying system, and control system is also divided into two power trains. Additionally, the incoming transmission lines are also assigned to power trains in such a way as to separate the associated cabling, protective relaying, and controls for each circuit of the double-circuit transmission lines into two distinct sources of offsite power. The Catawba 230kV switchyard design assures the independence of the redundant offsite power feeders to each nuclear unit. Refer to Figure 1 for a visual depiction of the Catawba 230kV switchyard and offsite power arrangement.

This event was initiated as a result of the PCB-18 current transformer "X" phase ground fault. The exact cause of the ground fault is still under investigation. In addition, while the event was in progress, the PCB-23 "Y" phase current transformer also failed, which contributed to the LOOP. The exact cause of this failure is also still under investigation. When the investigations are complete, Catawba will evaluate whether a supplement to this LER is necessary; if a supplement is warranted, it will be submitted to the NRC.

During the investigation of this event, it was discovered that the red bus differential relays were inadequately set, which resulted in the red bus tripping inappropriately. This, in conjunction with the PCB-18 current transformer "X" phase ground fault and the failure of the PCB-23 "Y" phase current transformer, caused all four bus lines from the two units to isolate. This resulted in the loss of all offsite power to the units. The root cause analysis for this event determined that in 1981, tap setting changes for the yellow and red bus differential protective relays to account for load growth were not implemented at Catawba. Power Delivery documentation was subsequently erroneously updated to indicate that the changes had been made.

1. The Emergency Response Organization directed the overall response to the LOOP event following the declaration of the NOUE.
2. Once all four essential busses were aligned to offsite power, the NOUE was terminated.
3. The red and yellow switchyard bus differential protective relays were adequately set and tested.
4. The PCB-18 "X" phase and PCB-23 "Y" phase current transformers were replaced.
